**Investigation of Explosion and Fire at Prudhoe Bay Well A-22  
North Slope, Alaska  
August 16, 2002**

**Alaska Oil & Gas Conservation Commission Staff Report  
November 17, 2003**

## **PBU A-22 Accident Investigation August 16, 2002**

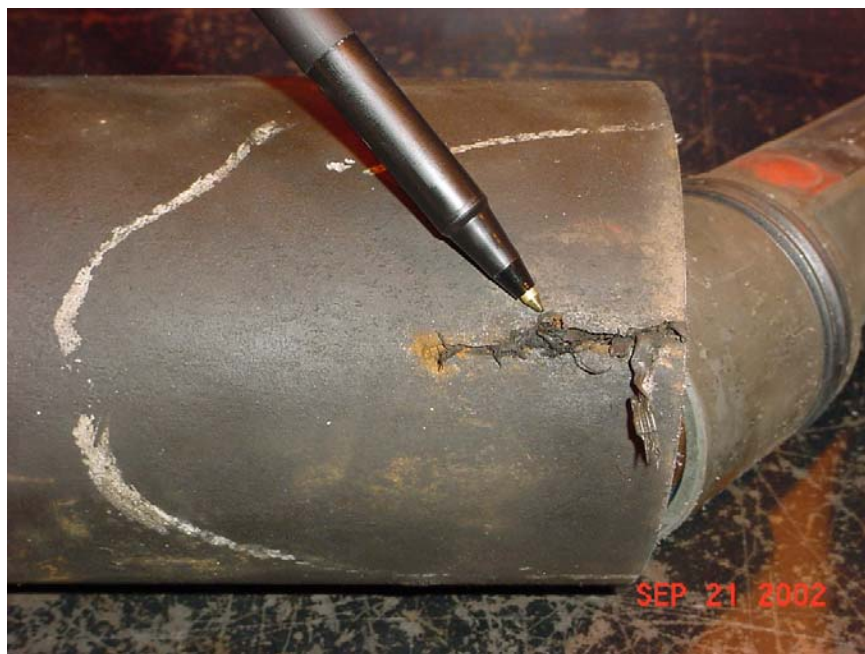
**Figure 3:** Well A-22 tubing split

Commission inspectors witnessed critical activities of the A-22 decompletion, including recovery of the tubing and damaged casing, and pressure tests of the tubing, casing and packer. Split tubing was recovered from the well, and assessed to determine if it was a contributing factor in

the incident. BPXA stated the tubing split was the result of a string shot used to remove excess build up inside the pipe prior cutting of tubing for removal.<sup>18</sup> Photographs taken of the split tubing (Figure 3) and the fact that no liquid hydrocarbons were released from A-22 appear to confirm BPXA's assessment. Inconsistent BPXA pressure records for tubing and IA provide no useful information in determining whether pressure communication occurred due to a tubing leak.

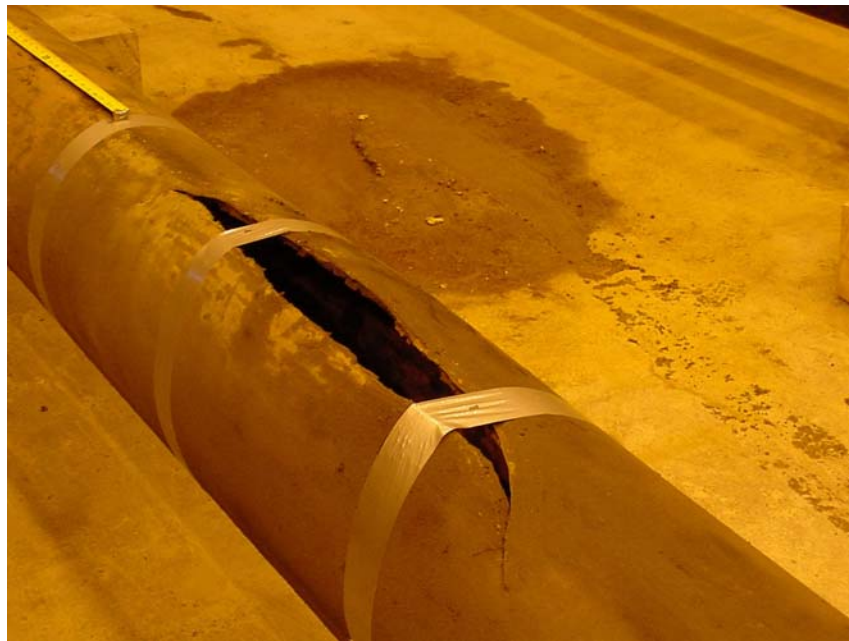
**Figure 4:** Damaged surface casing recovered from Well A-22

Visual examination of recovered 13-3/8" surface casing (Figure 4) revealed no apparent corrosion or wear; both were identified as possible reasons for pipe failure early in the investigation (before the pipe was recovered). The pipe was bulged over a distance of 15 feet, with a ragged split, consistent with a high pressure burst. A 32-foot section of pipe was sent to Edison Welding Institute for detailed mechanical testing and measurement, metallography, and chemical analysis. Full scale burst testing of a downstream section of the recovered pipe was performed. The burst testing replicated the actual failure (ductile rupture) and demonstrated a measured

burst for the A-22 surface casing of approximately 7,700 psi.<sup>19</sup> The fact that the actual burst pressure is significantly higher than the published burst is expected, given the safety factors involved.

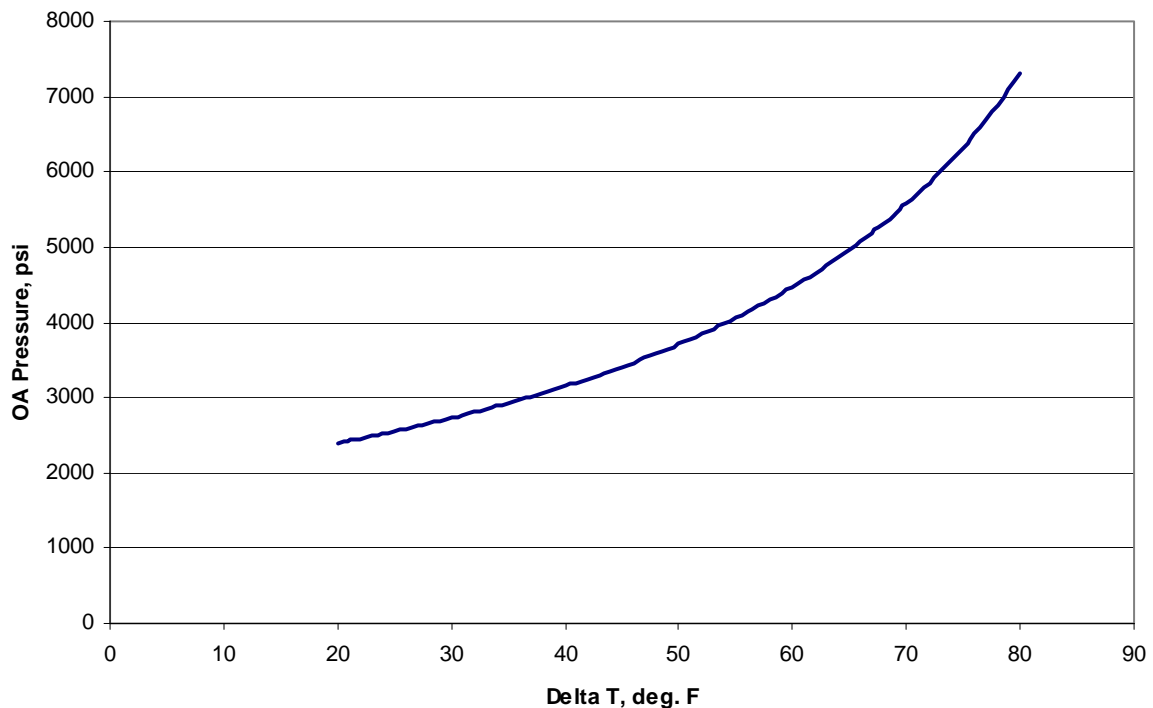
**Figure 5:** A-22 OA Pressure as a Function of Temperature Change; 1,900 psi initial pressure

Figure 5 represents calculated A-22 OA pressure and temperature as the well was being started. Initial OA pressure was 1,900 psi and initial temperature was about 40° F. No pressure was bled from the well prior to startup. As warm produced fluids flowed, A-22 heated from its initial temperature to its eventual in-service temperature of about 116° F (historical information). The resulting temperature change, or delta T, was 76° F. Figure 5 reveals that as A-22 heated, the published burst pressure rating of the well’s surface casing<sup>22</sup> (5,380 psi) was exceeded at a delta T of about 68° F. In other words, the burst rating was exceeded before the well had reached its historic operating temperature.

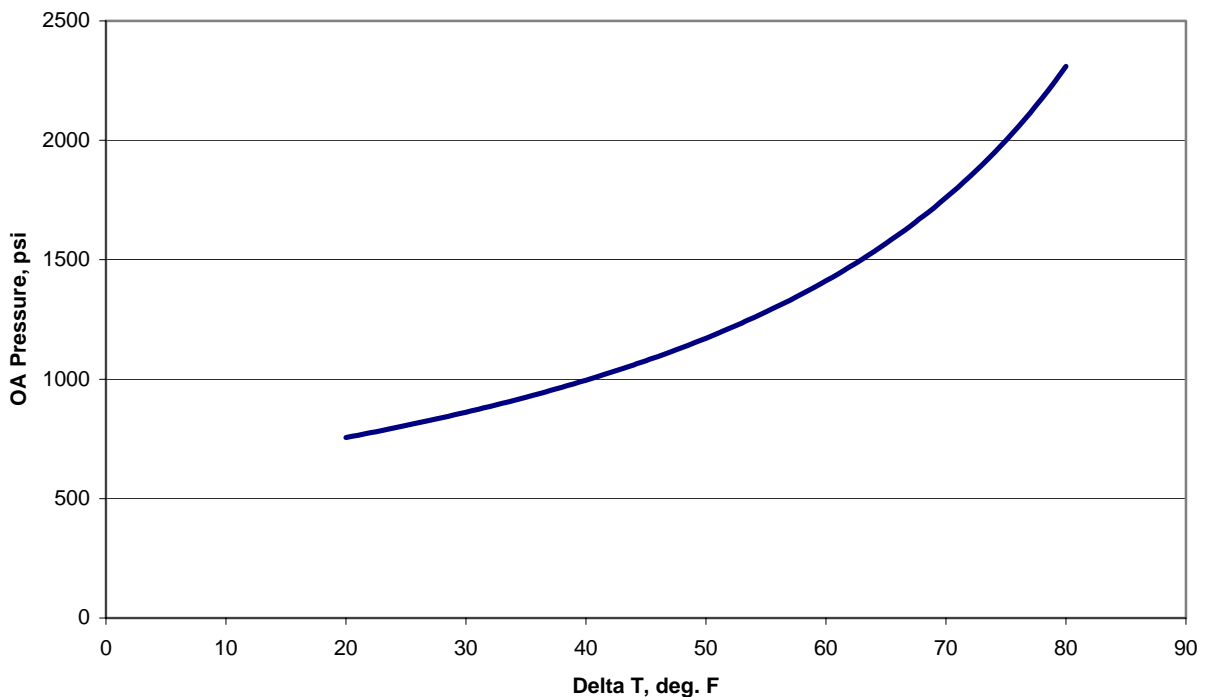
**Figure 6:** A-22 OA Pressure as a Function of Temperature Change; 600-psi initial pressure

Figure 6 illustrates the effect of a lower initial pressure on the final OA pressure at in-service temperature. The initial OA pressure of 600 psi corresponds to a final OA pressure of less than 2,500 psi at maximum delta T.

If the OA pressure in A-22 had been bled to the historic value (600 psi), the final OA pressure would not approach the published burst rating of the surface casing (5,380 psi), and would have been about one-third the actual failure pressure (7,700 psi). In fact, OA pressure probably would not have exceeded the casing pressure test (3,000 psi) performed before A-22 was placed in service on August 15, 2002.
